HISTORIC STRUCTURES REPORT

CROOK HOUSE

SEPTEMBER 1984

SAN JUAN ISLAND
NATIONAL
HISTORICAL PARK

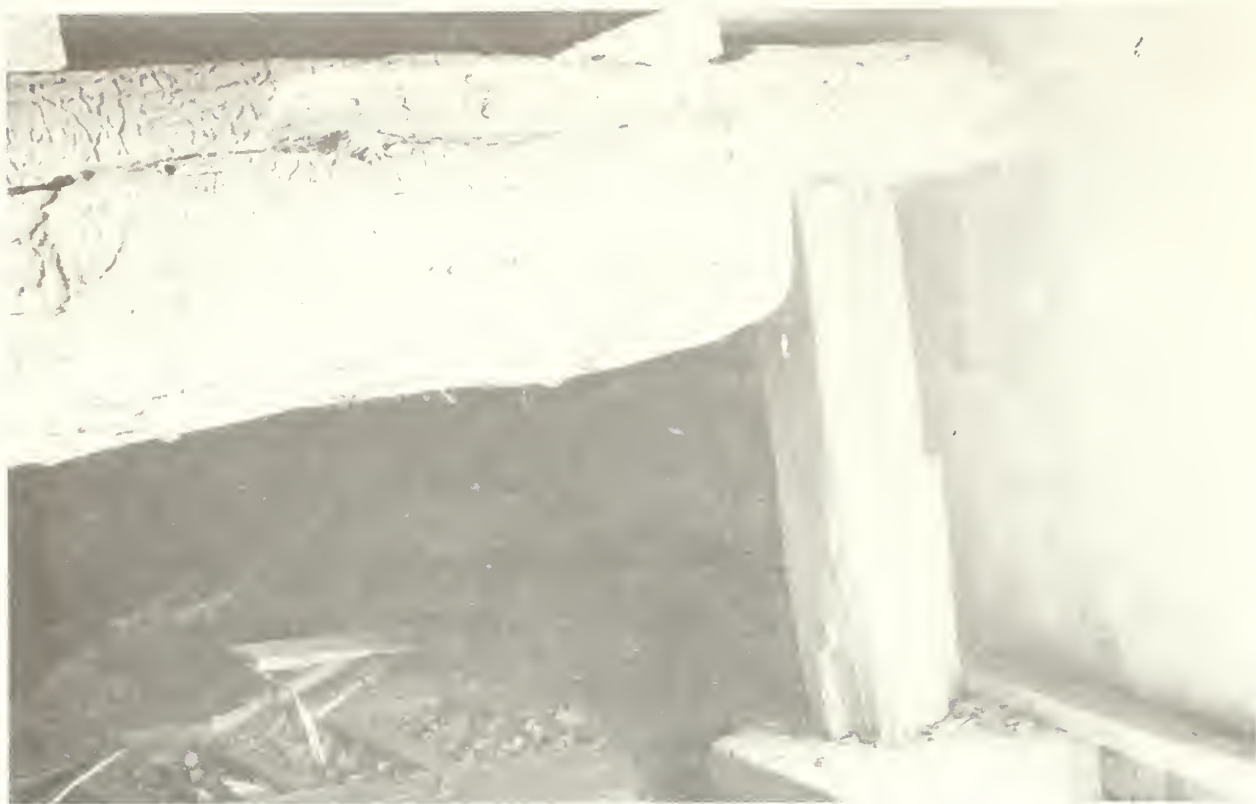
FIGURE 34 Crook House foundation, west end under porch, 1984. Photo by Barry Schnoll, National Park Service.

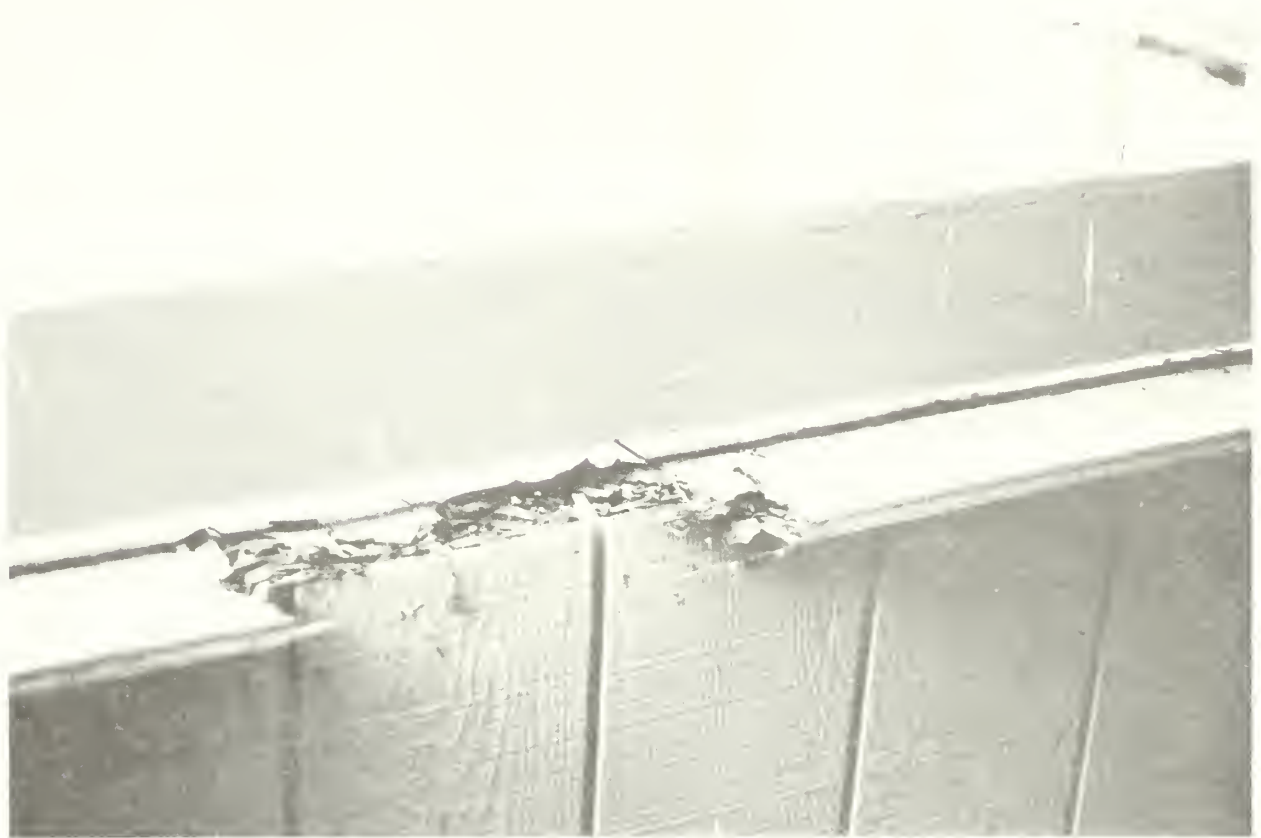
FIGURE 39 Deteriorated first floor porch deck, southwest corner of Crook House, 1984. Photo by Barry Schnoll, National Park Service.

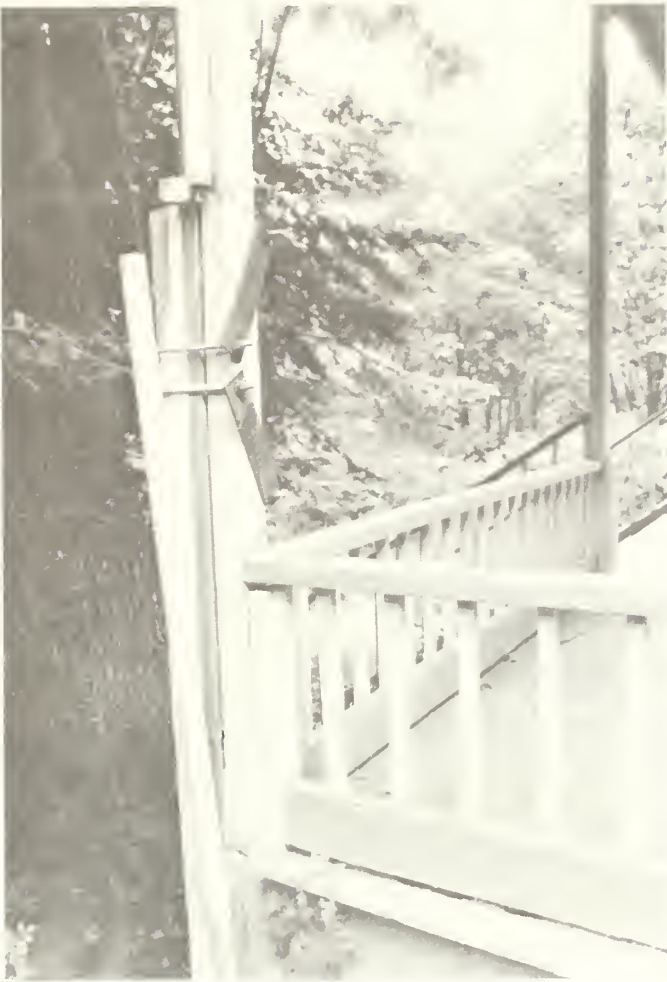
The CONDITION of the porch structure presents the most immediate and visible areas of concern. The south-west column has an auxiliary

FIGURE 40 (Above left) Temporary bracing for southwest corner porch column, 1984. Photo by Barry Schnoll, National Park Service.

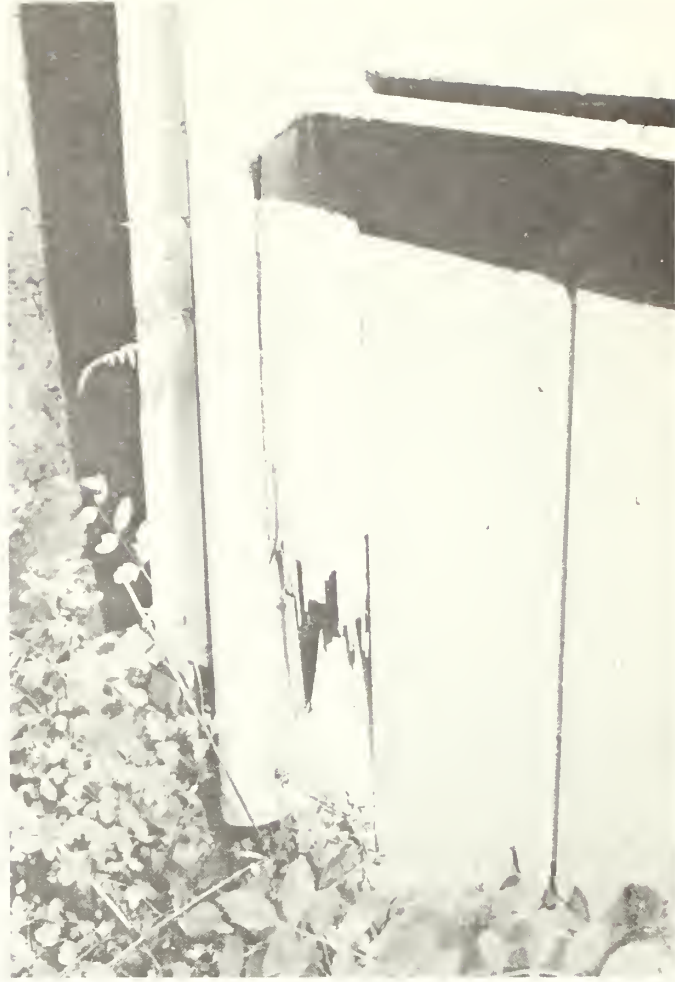
FIGURE 41 (Above right) Deteriorated skirting under porch deck in southwest corner, 1984. Photo by Barry Schnoll, National Park Service.

The skirting is basically in good condition, but adequate care should be taken to remove soil, vegetation and debris from contact with

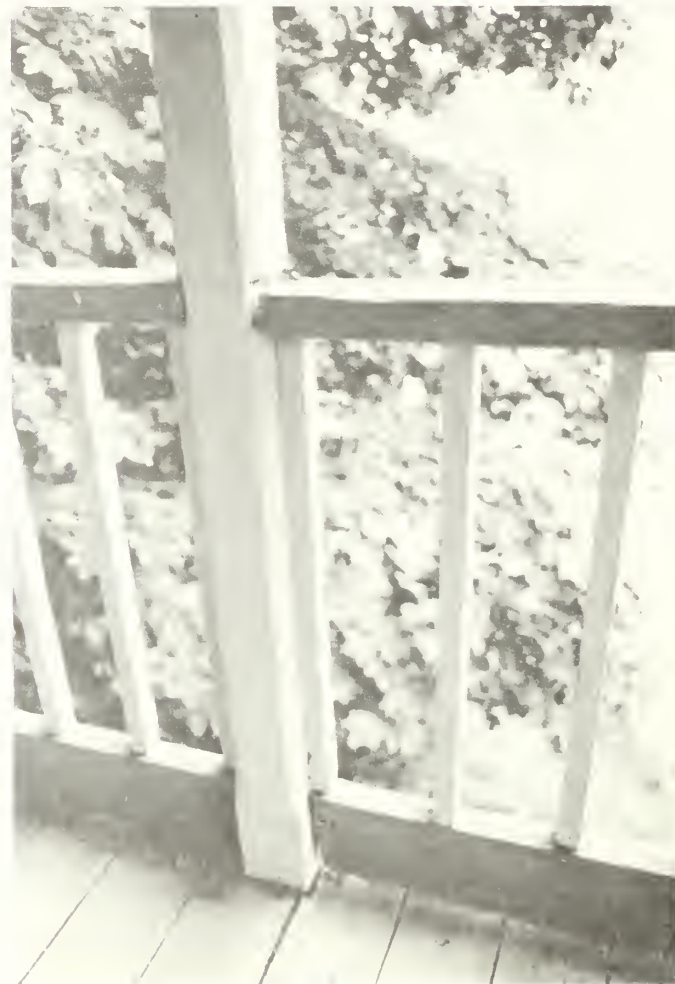
FIGURE 42 (Right) Second floor porch railing. The top rail is separating from the column and the balusters are loose, 1984. Photo by Barry Schnoll, National Park Service.

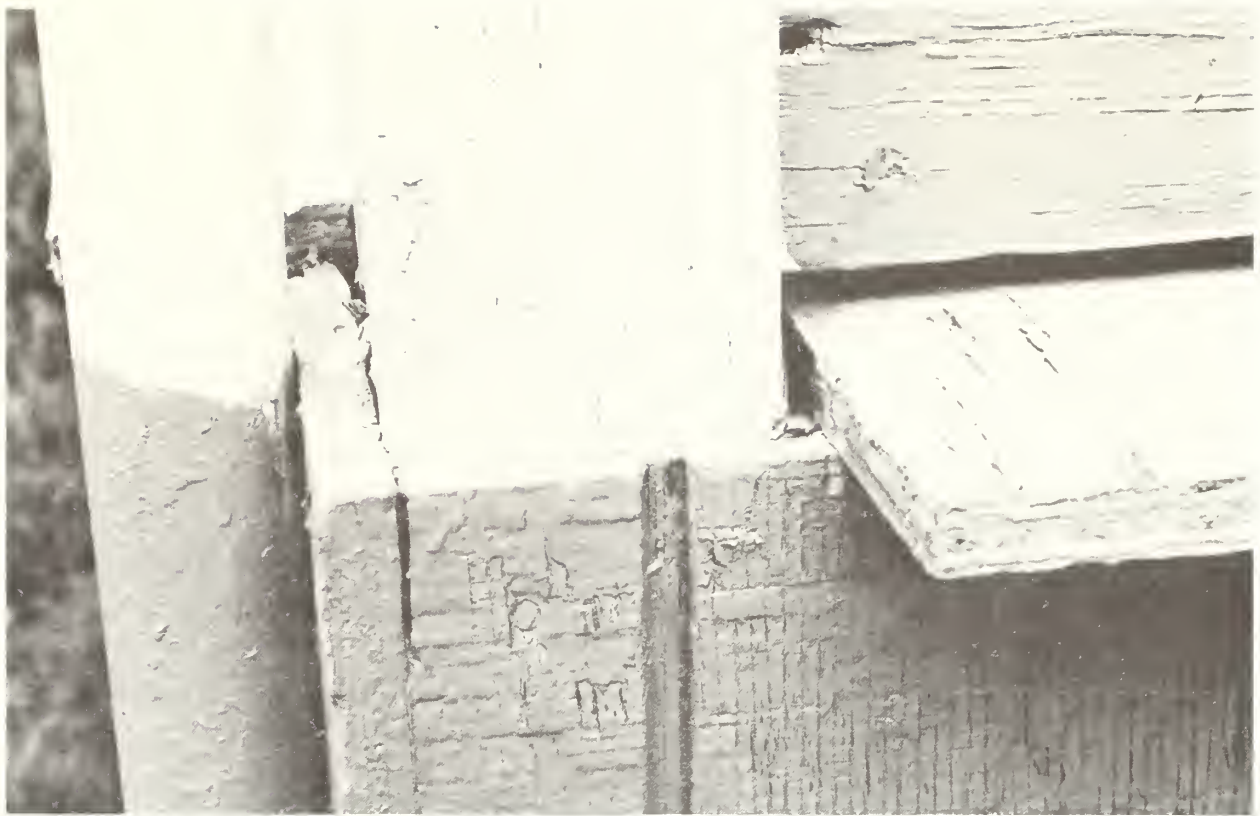
FIGURE 43 Northwest corner of Crook House porch, 1984. Lack of sealant allows moisture penetration. Photo by Barry Schnoll, National Park Service.

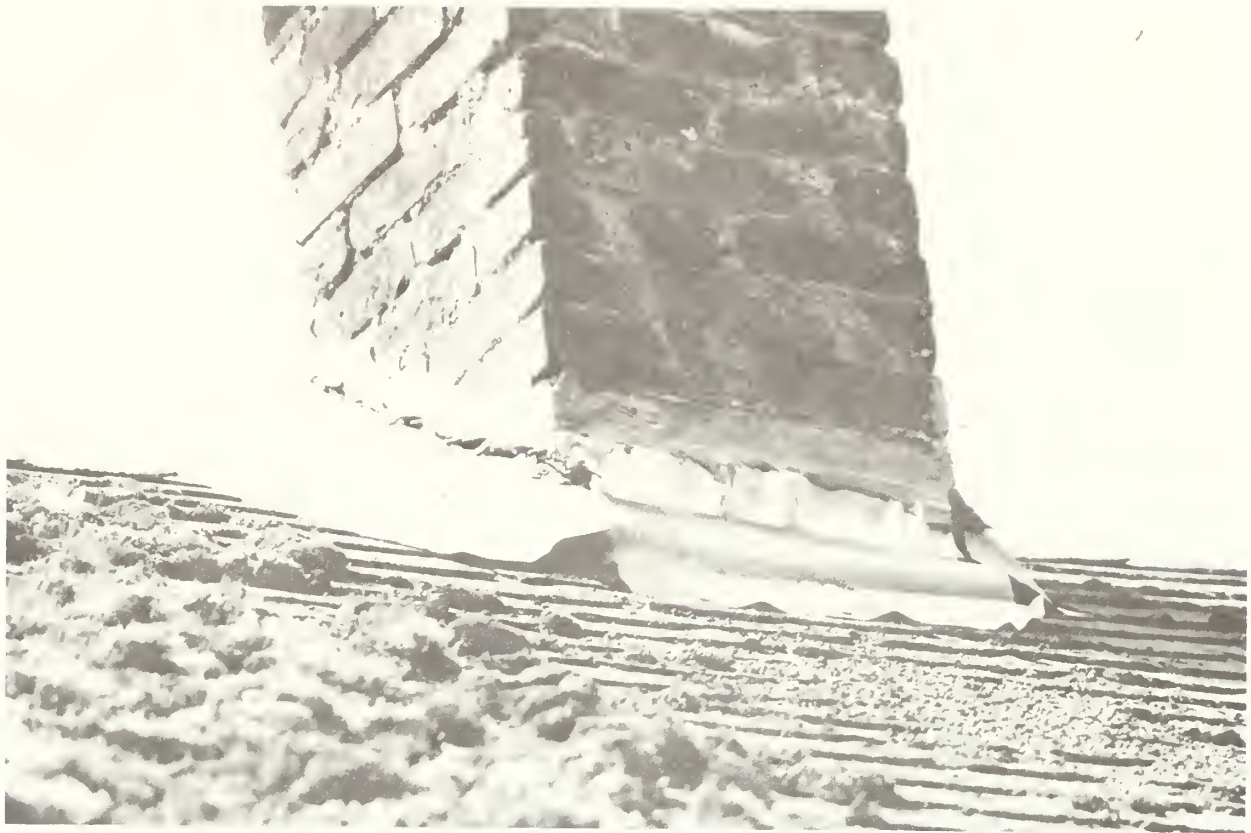
FIGURE 45 East gable roof of Crook House, 1984. Shingles, brick and flashing show advanced deterioration. Photo by Barry Schnoll, National Park Service.

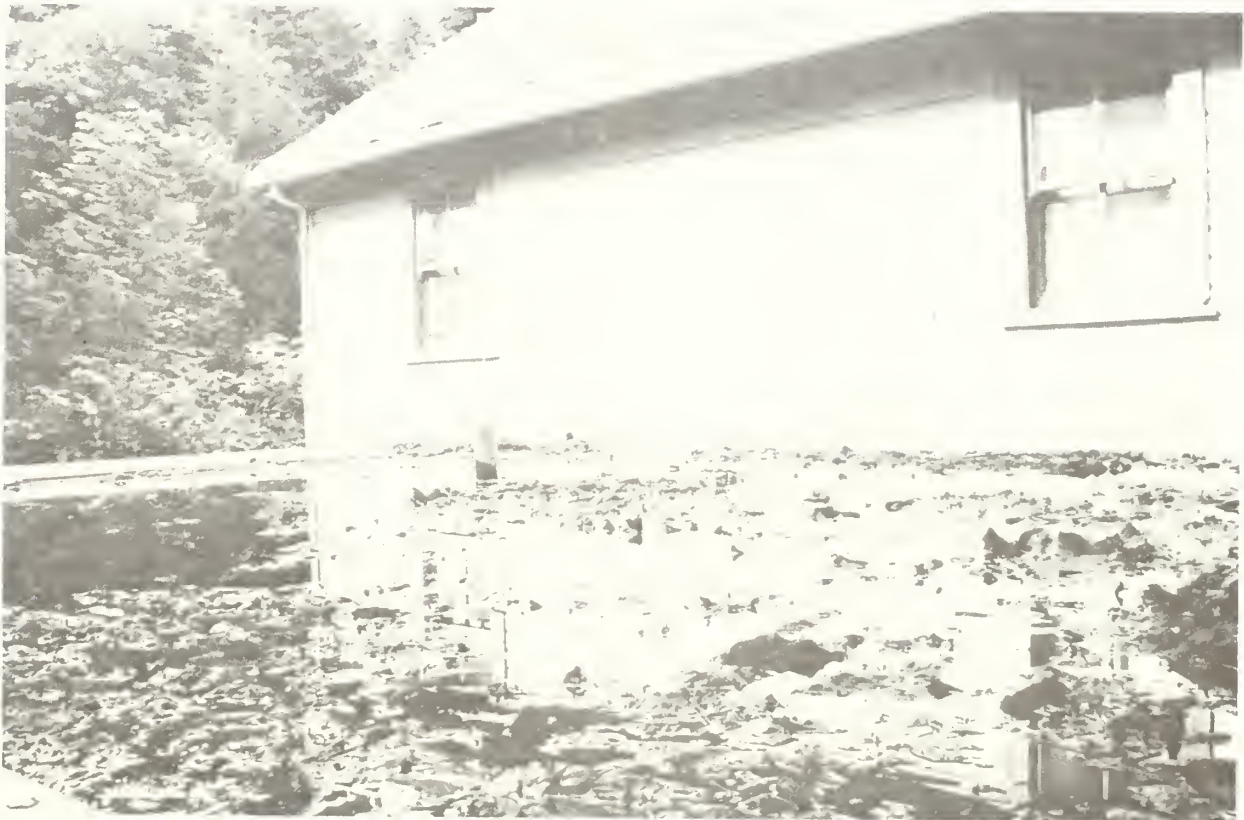
FIGURE 46 Crook House addition, 1984. Flat roof contributes to ponding. Photo by Barry Schnoll, National Park Service.

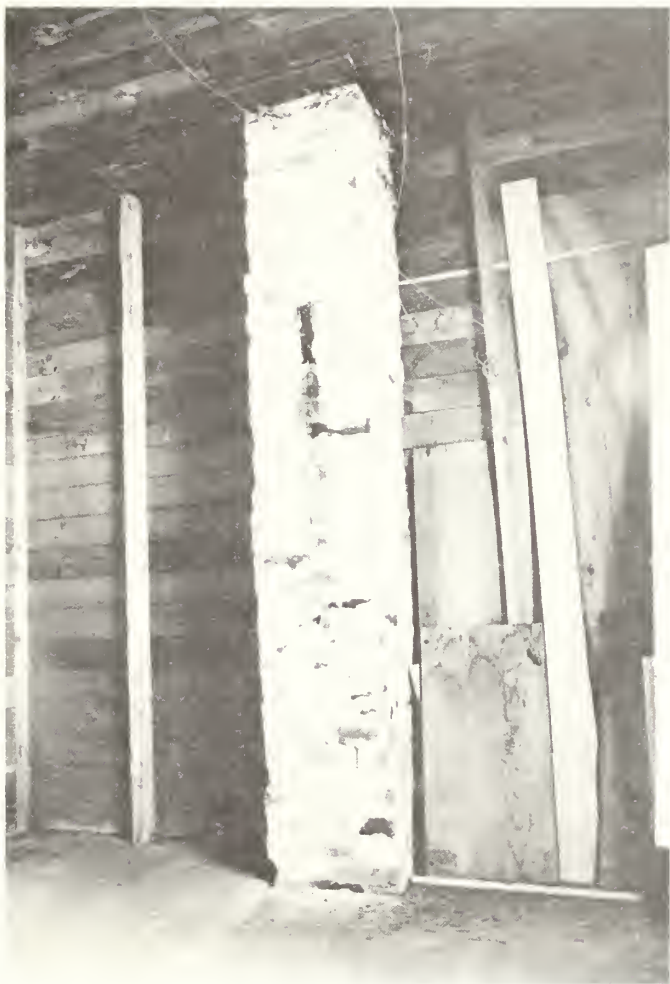
FIGURE 47 Chimney on unfinished west wall of Bedroom #3, Crook House, 1984. Stove flue hole filled with mortar. Photo by Barry Schnoll, National Park Service.

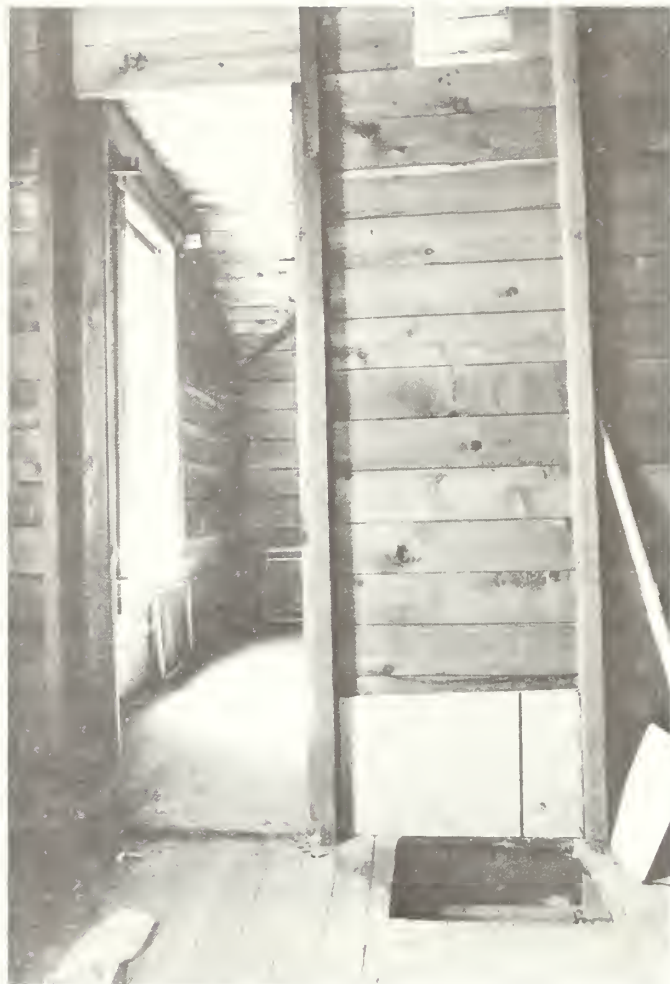
FIGURE 48 Bedroom #4 of Crook House, 1984. Upstairs rooms were never finished. Opening in floor indicates location of dismantled chimney. Photo by Barry Schnoll, National Park Service.

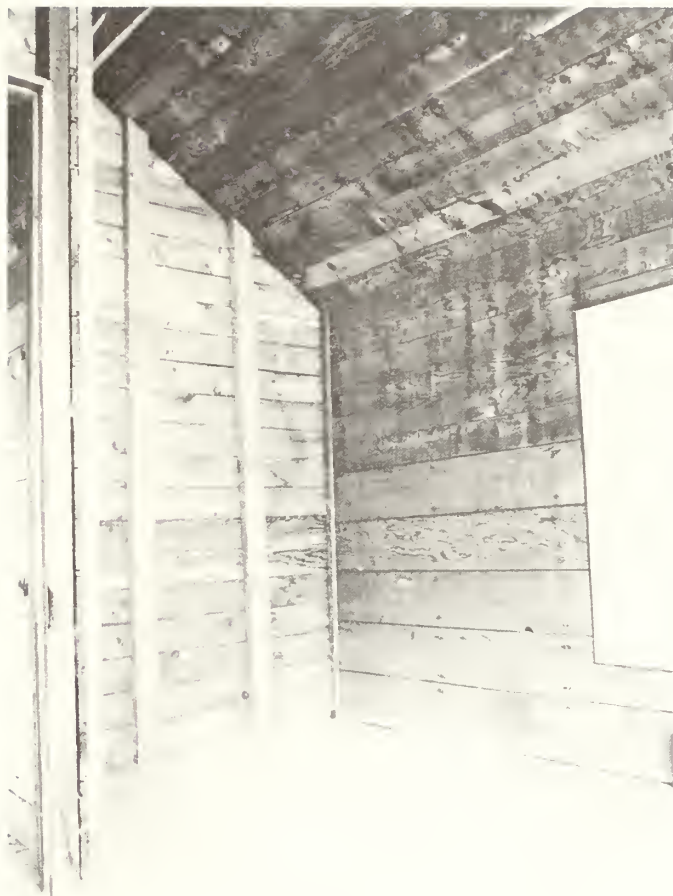
FIGURE 49 Unfinished interior of Bedroom #4, Crook House, 1984. Ceiling drop and studs laid flat on the north wall. Photo by Barry Schnoll, National Park Service.

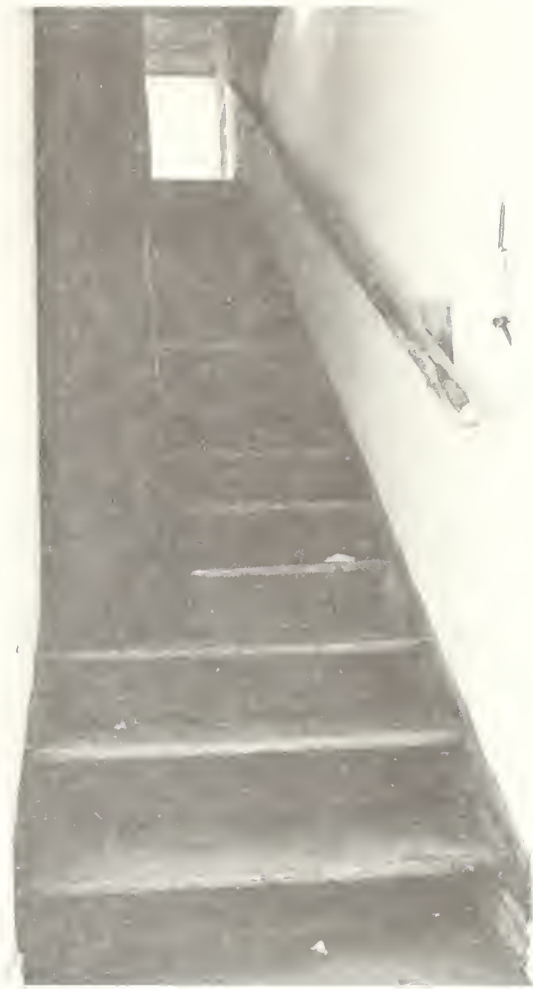
FIGURE 50 Crook House staircase, looking west, 1984. Tread depth and riser height are not consistent. Photo by Barry Schnoll, National Park Service.
